June 2000

To: Cannondale Retailers
From: Cannondale Corporation
Re: Inspection of CODA Tarantula cranksets

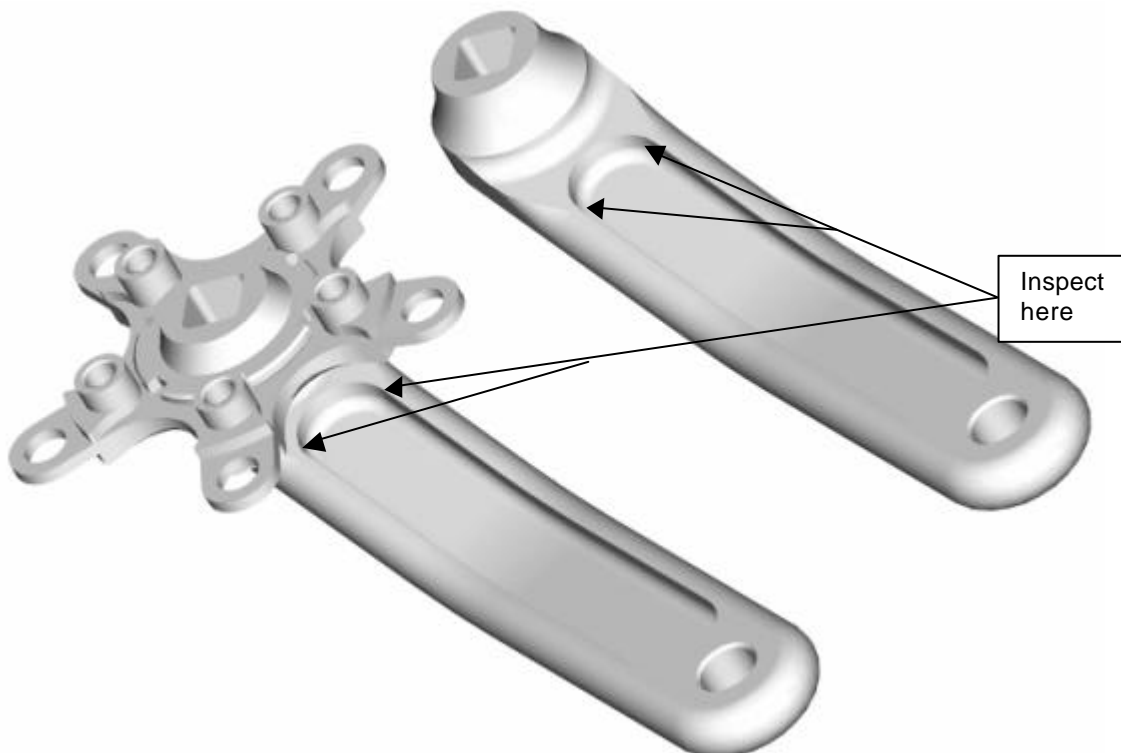
With enough use, Cannondale has seen some of these cranks develop cracks. Such cranks have reached the end of their fatigue life. Because the cracks develop in one area and are relatively easy to spot, we want you to know where to look.

Please make it a part of service on any bicycle equipped with CODA Tarantula cranks to inspect the crank arms for cracks. Clean the inside of the left and right crank arms. Carefully inspect the inside face of the both cranks, at the end of the pocket which is closest to the bottom bracket spindle. See Illustrations.

If a crack is noted, however small, please do not use the crankset. Please call Cannondale for warranty replacement at 800-726-2453. If no crack is noted the crank has more life and can continue to be used.
